State of California
Transportation Agency
Division of Highways
Materials and Research Department

FAULTING OF PORTLAND CEMENT CONCRETE PAVEMENTS

Spellman, D. L., Woodstrom, J. H., and Neal, B. F., "Faulting of Portland Cement Concrete Pavements", State of California, Transportation Agency, Department of Public Works, Division of Highways, Materials and Research Department, Research Report No. M&R 635167-2, January 1972.

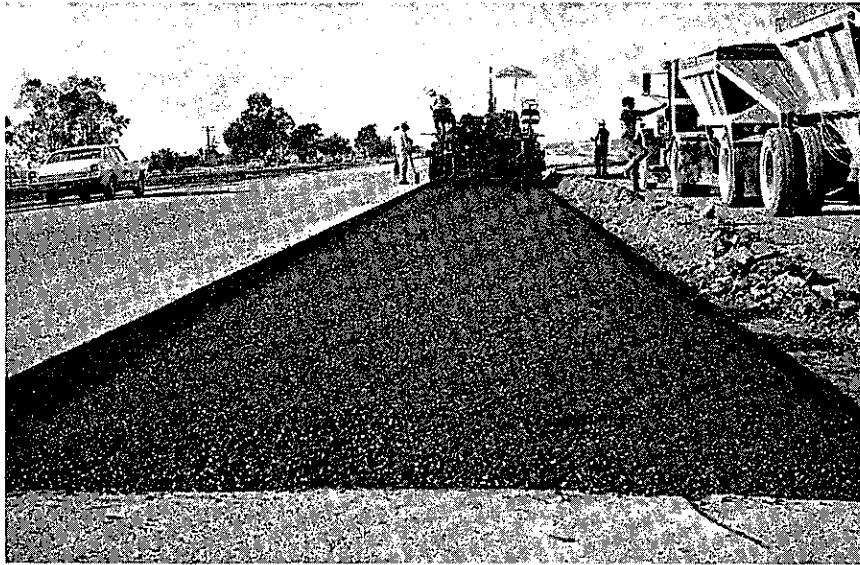
The aggregate base of the shoulder was replaced with permeable AC (very open graded) in a 1000-ft. section. (See Figure 1.)
3. US 99, South of Sacramento - Two 2000-ft. sections
 - A. A seal consisting of a fiberglass reinforced plastic strip - 2 ft. wide, placed along the edge of the slab and over the widened CTB in the shoulder. Aggregate base and AC then placed as usual. (See Figure 2.)
 - B. Aggregate base replaced with permeable AC. (See Figure 3.)
4. I-205, South of Sacramento - 2000-ft.

Fig. 1 Permeable asphalt concrete shoulder being placed on I-5

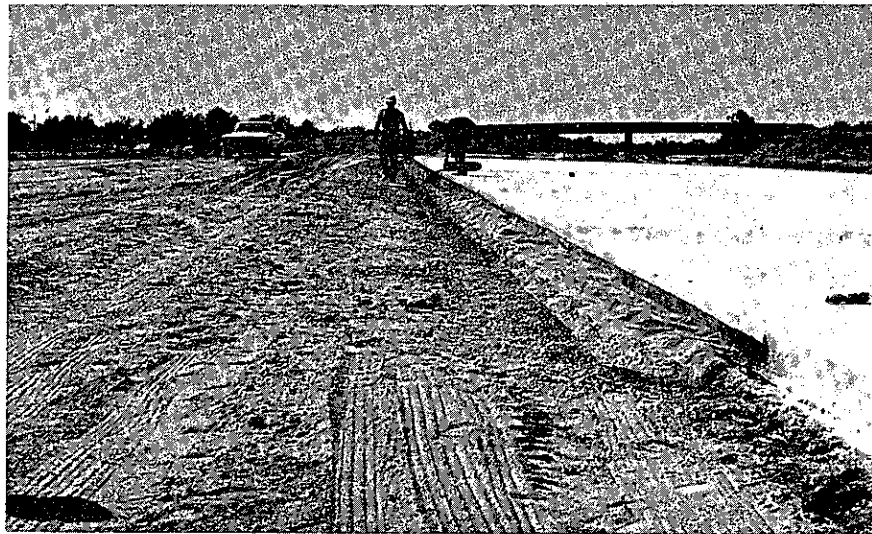
Fig. 2 Fiberglass reinforced plastic placement, US 99

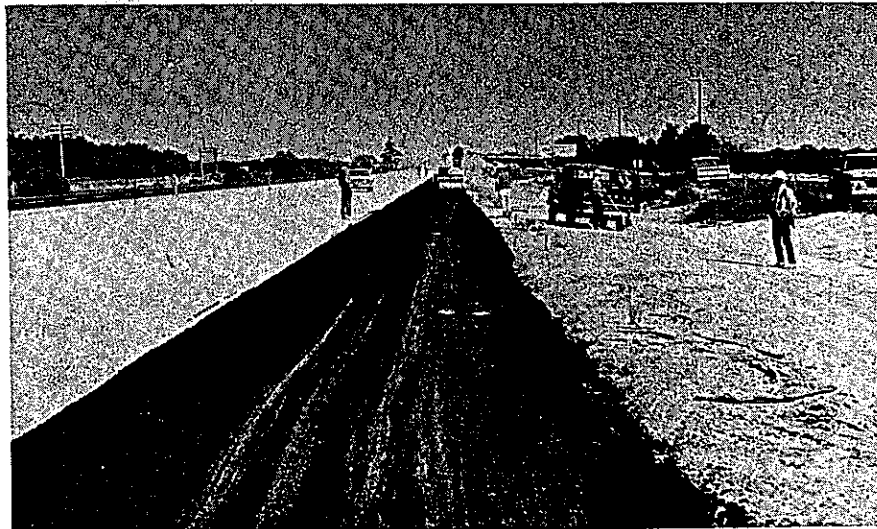
With less than 10% of the aggregate passing the No. 4 sieve and using 2% asphalt, there was some difficulty in compacting the permeable AC. After some experience, it was found that cooler mix temperatures and lighter rollers (6-8 tons) provided better results. On the shoulder replacement test section, wheel rolling in the confined area was felt to be sufficient. A steel wheeled roller was used on the dense graded surface course. The cost of the permeable AC under the experimental conditions was 20% to 40% more than the dense graded mix.

Fig. 3 Rolling of Permeable asphalt concrete,
US 99

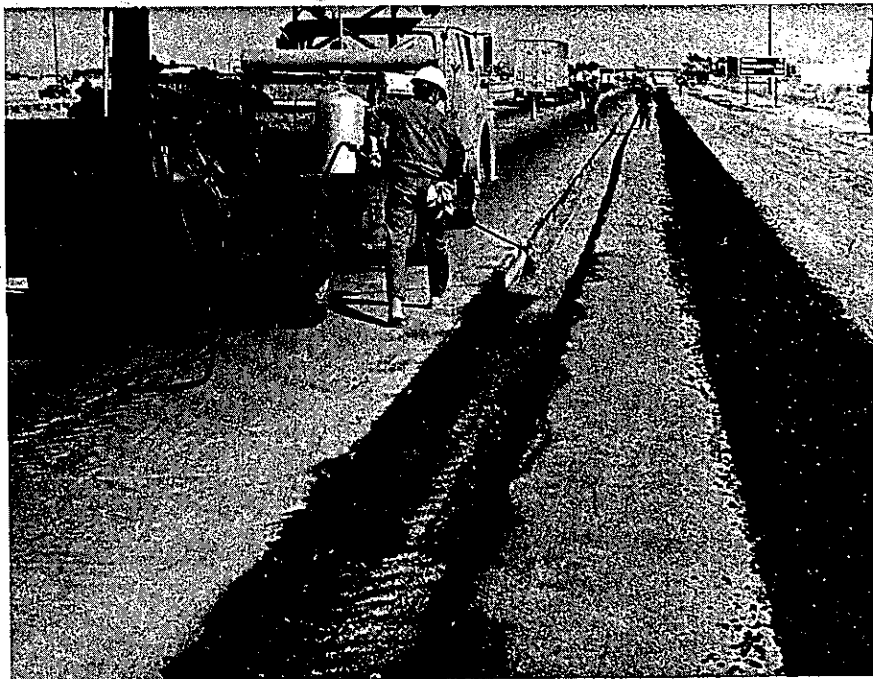
This was a partial shoulder replacement of a pavement that had been in service about 8 years and had moderate faulting. A 2-ft. wide section of the outer shoulder adjacent to the slab was removed down to the bottom of the slab. Loose material was broomed away, a tack coat of asphalt emulsion applied, then 0.5-ft. permeable AC and 0.25-ft. dense graded AC to complete the shoulder. A 2000-ft. section was replaced in both the eastbound and westbound lanes. The basic objective of this work was to eliminate erodable shoulder material from the areas adjacent to the slab to see if faulting could be arrested. In addition to providing erosion resistance, the permeable AC is expected to provide better drainage which may also help reduce faulting tendencies. Performance of the test sections will be compared to that of adjacent untreated areas. (Reconstruction features are shown in Figure 4.)

Fig. 4 Partial shoulder replacement - I-80

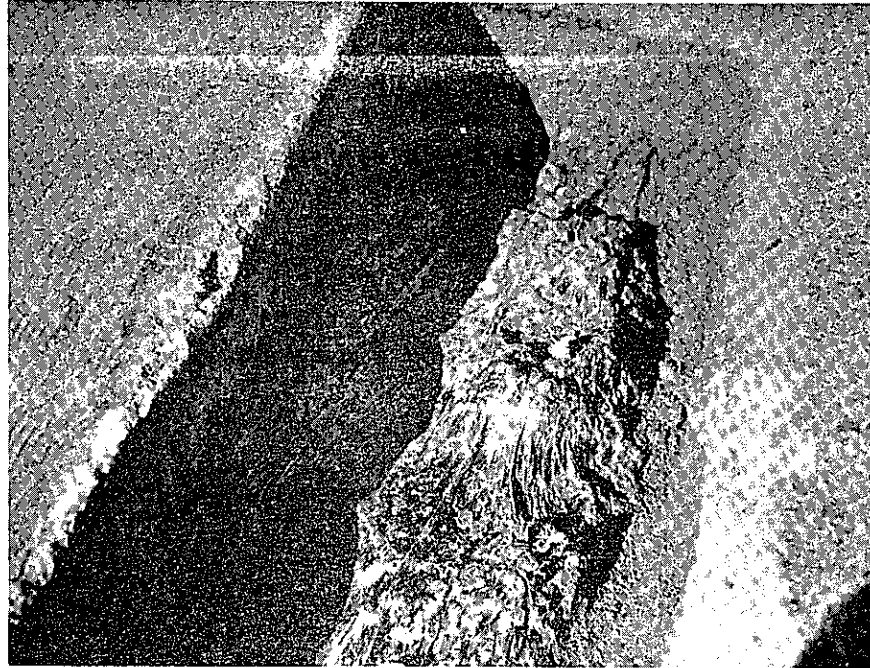
Some difficulty was also encountered in placing the membranes. Although an asphalt emulsion was satisfactory as an adhesive for the membranes on flat surfaces, it would not hold them for a sufficient time on vertical surfaces. As a result, it was necessary to hold the membrane against the slab by hand while aggregate base was being placed against it. Finished placement was proven satisfactory, at least for the plastic, by opening up the shoulder about 8 months later for examination. The material was found to be solidly stuck to the concrete and CTB, and had conformed to all irregularities caused by excess concrete left on the edge during pavement construction. (See Figure 5.) The material cost for fiberglass reinforced plastic was about \$600 per mile, while the cost of the layered coal tar and fiberglass was about three times as much. The underground life of the plastic is unknown, but if the theory of its use is proven, it would probably be sufficient to at least delay faulting for many years.

Fig. 5 Shoulder opening showing plastic conforming to irregularities

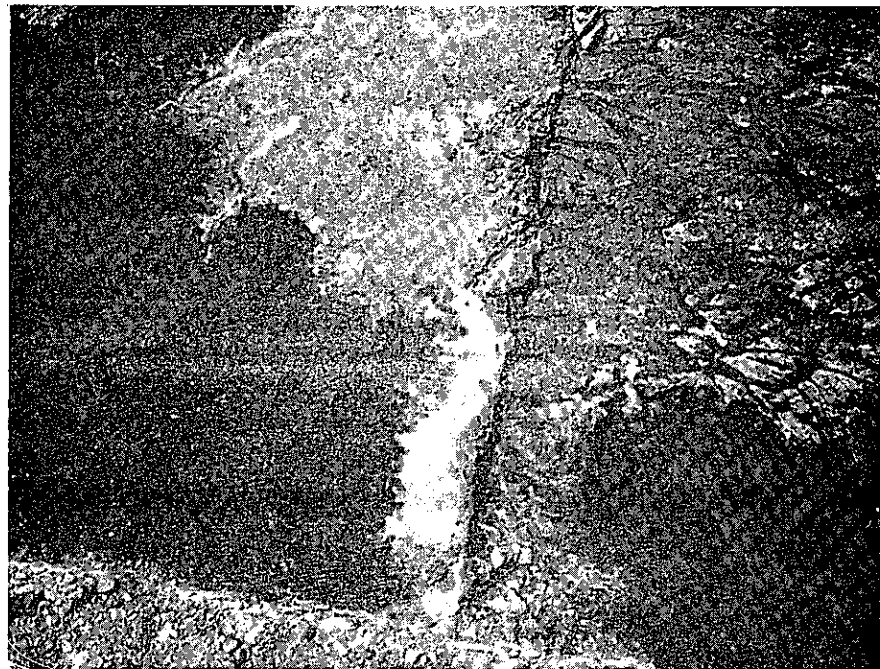
Although base settlement has long been suspected as a cause of faulting, there was no evidence found during the field investigation of any such settlement. (All pavements opened had cement treated base - CTB.) There was, however, positive evidence of erosion of the base surface under the leave slab. The evidence was in the form of rivulets caused by water movement and might result in some lack of uniform support but would not allow the slab to be depressed (see Figure 6). The top portion of the CTB at many locations has been found to be loosely cemented and readily erodable. While drying of the surface before curing may be responsible for part of the problem, much is felt to be due to the trimming operation used to conform to grading tolerances. Since a high base will result in thin pavement for which a Contractor is penalized, and a low base results in the use of excessive concrete, considerable effort is exerted in obtaining the proper grade. Trimming is usually done about an hour or more after original placement. The surface material, once loosened, is never fully rebonded and so does not form a monolithic erosion resistant base.

Fig. 6 Channels indicating water movement on cement treated base surface

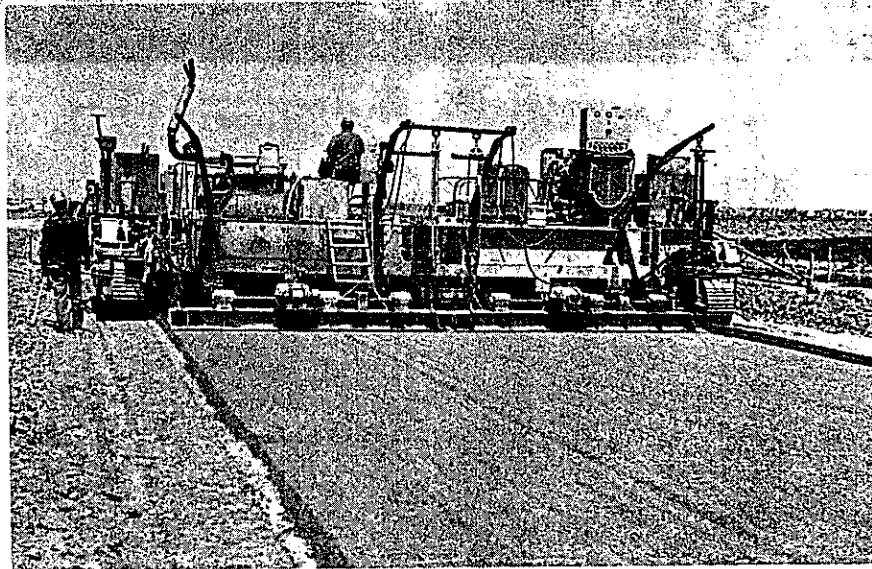
Recently it has been noted that a few contractors are changing their CTB placing methods. They have gone to central mixing, whether required or not, and to placing with a slipform paver. Instead of a wet mix and internal vibration, they use the regular dry mix and a vibrating screed behind the paver, followed by rollers. This results in a much harder appearing surface and trimming is seldom if ever necessary. Unfortunately, there is no test method available for measuring abrasion resistance of CTB in place. If the trend to this type of construction continues, our objection to CTB due to trimming may be overcome (see Figure 7).

Fig. 7 Placing cement treated base with slipform paver
